Service Manual

Energy Recovery Ventilator

FV-16VEC1S

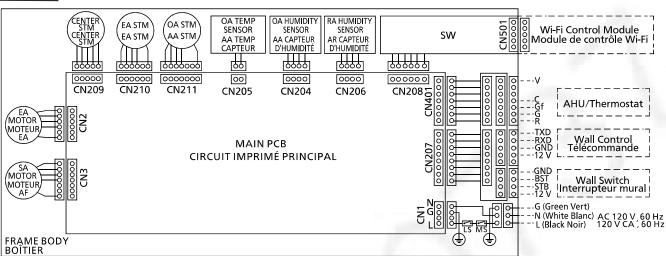
3. Wiring diagram

STM: Stepper Motor Moteur à engrenages

LS: Limit Switch Interrupteur de fin de course SW: Switch PCB Circuit imprimé du commutateur

MS: Main Switch Interrupteur principal

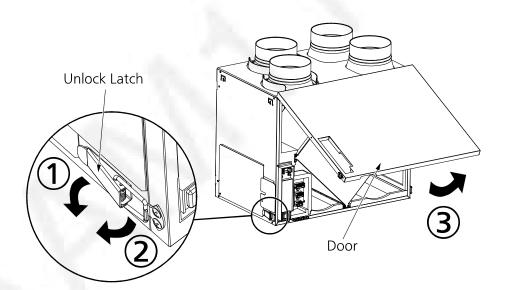
- Electric shock may result. Disconnect power by switching off main switch, then unplug before working on the unit. If a standby switch is connected, it is recommended to switch it off first.
- Routine maintenance must be performed every 2 or 3 months. clogged filters may cause condensation on the unit due to air flow reduction.
- Please wear gloves to avoid pinching fingers during maintenance.
- Please pay attention to dust, condensation water, or parts that may drop down when the door is opened.
- \bigcirc Never use gasoline, benzene, thinner or any other such chemicals to clean the ERV.
- \bigcirc Do not allow water to enter ERV.
- O Do not immerse resin parts in water over 60 °C.
- 1 Open the door by unlocking the latches.

Clean the OA filter, RA filter and energy recovery core.
