PESMX24120005CE

Service Manual

Energy Recovery Ventilator

FV-13VEC1T

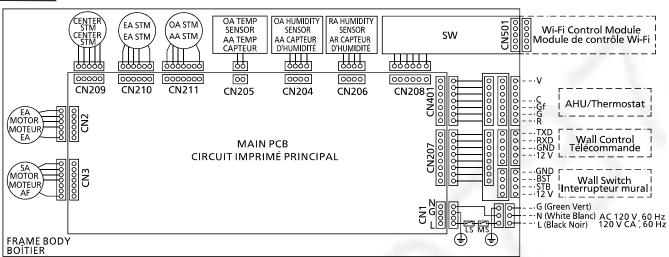
3. Wiring diagram

STM : Stepper Motor Moteur à engrenages LS : Limit Switch Interrupteur de fin de course SW : Switch PCB Circuit imprimé du commutateur

MS: Main Switch Interrupteur principal

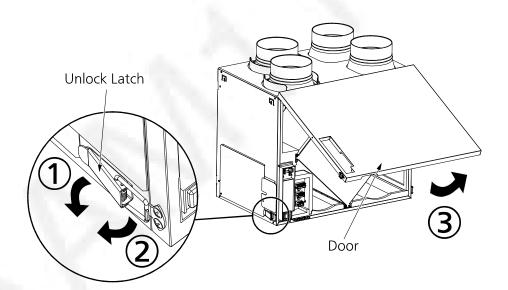
- Electric shock may result. Disconnect power by switching off main switch, then unplug before working on the unit. If a standby switch is connected, it is recommended to switch it off first.
- Routine maintenance must be performed every 2 or 3 months. clogged filters may cause condensation on the unit due to air flow reduction.
- Please wear gloves to avoid pinching fingers during maintenance.
- Please pay attention to dust, condensation water, or parts that may drop down when the door is opened.
- \bigcirc Never use gasoline, benzene, thinner or any other such chemicals to clean the ERV.
- O Do not allow water to enter ERV.
- \bigcirc Do not immerse resin parts in water over 60 $^{\circ}$ C.
- 1 Open the door by unlocking the latches.

Clean the OA filter, RA filter and energy 2 recovery core.

It is suggested to replace the OA filter every 6 months. Please fill in beginning time on new OA filter before replacing.
